Final report AA Project Nova Cura

Company: Nova Sea Transport

Senter Novem project number: SMIK09001

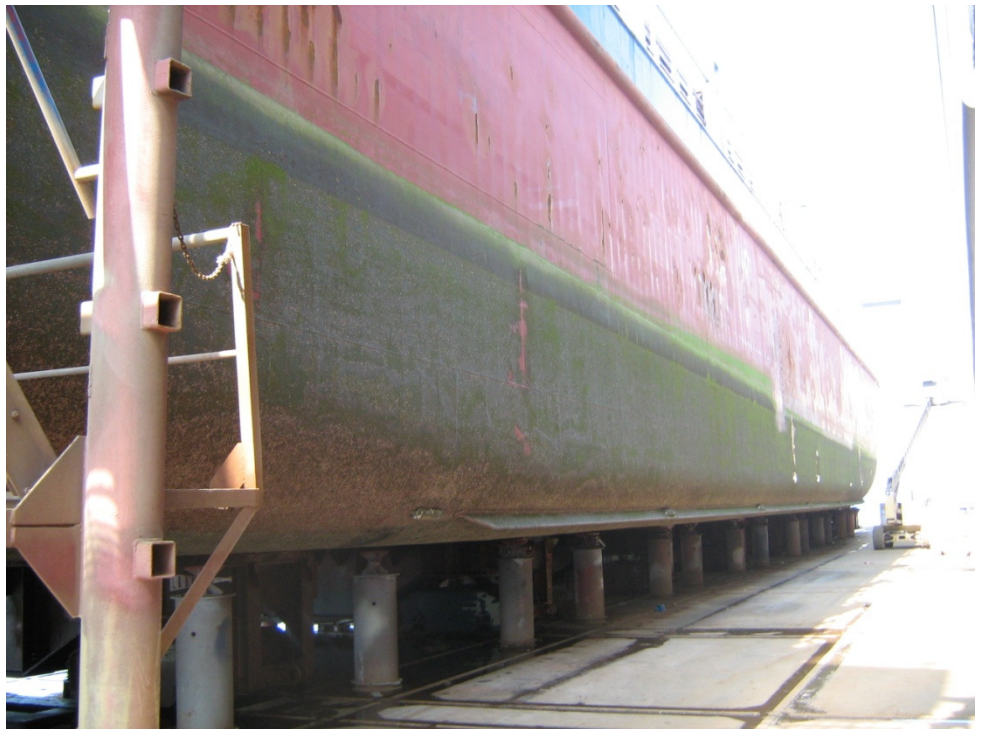
In the photograph above, you'll see the situation after the trips mentioned. Cruising speed and fuel consumption were severely affected. The cruising speed was 11 knots at 90 % pitch power ratio, and fuel consumption was measured at 11 tons per day. The entire hull was fouled with barnacles, seaweed and other organisms. The box coolers were full of barnacles and the cooler ribs were covered in growth. This drastically reduced cooling ability and, as a result, the vessel could not sail at full steam. Even auxiliary motors were affected by the excessive temperatures. The entire hull was high-pressure cleaned metre by metre and was then touched-up using paint without any antifouling properties.

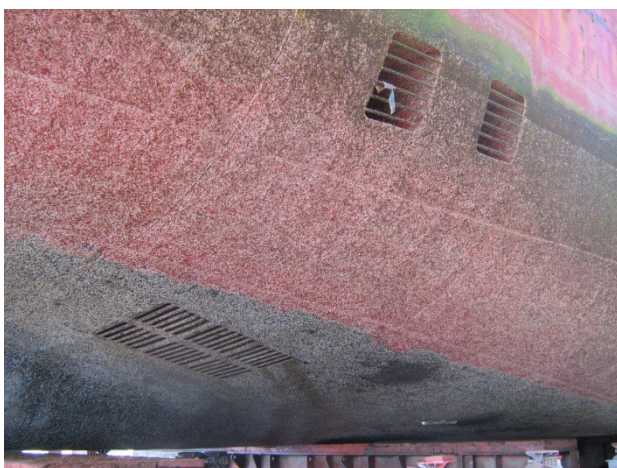
Nova Cura stern prior to the Special Survey 200

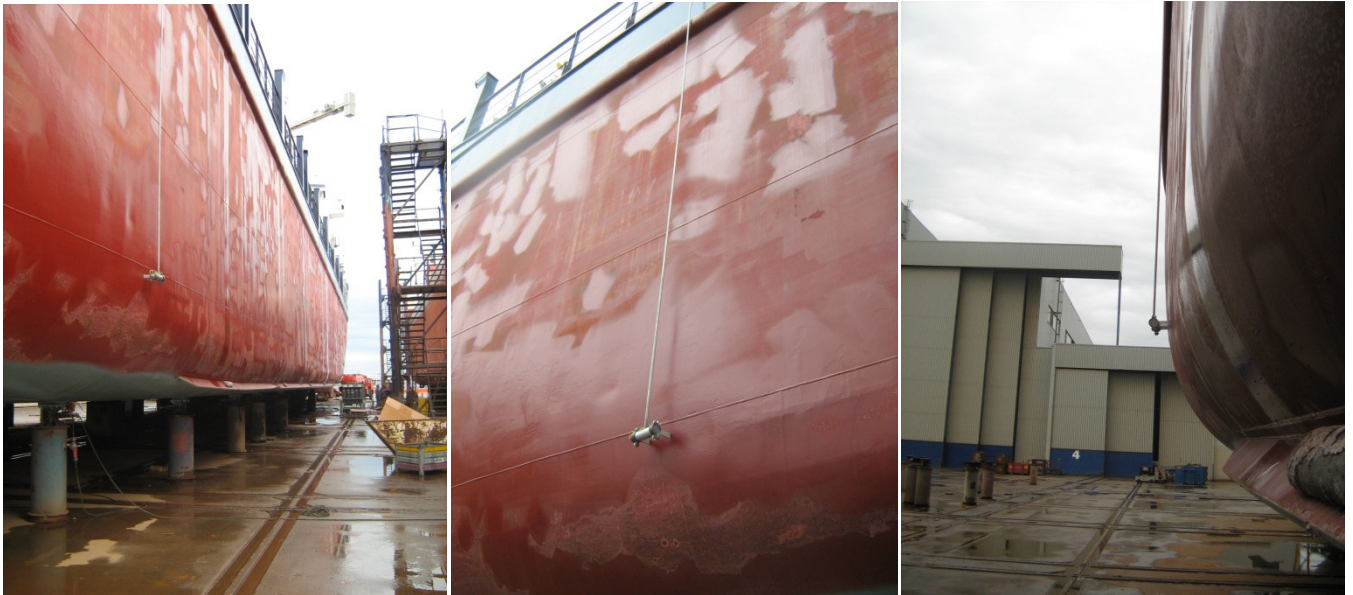
At the end of the vessel's stint in the shipyard, the hull was cleaned and touched up with normal paint. You'll notice that the ultrasound transmitters (USAF) are placed exactly in the centre of the area most affected by fouling.

The decision was made to go ahead with the AA project. Special ultrasound pods that emit a specific frequency were supplied by Luykx Ultrasound BV. These pods were hung from simple galvanised tubing on both sides of the Nova Cura, one at the front of the starboard side facing backwards and one at the back of the port side facing forward. Ultrasound pods were also placed inside the box coolers. These pods did not form part of the AA project and were obtained at the expense of Nova Sea Transport. Before these pods were fitted, the box coolers were removed and treated in an ultrasound bath that removed all the fouling, while the cooling tubes were provided with a layer of special paint. The box cooler housings were sprayed clean and painted, and the coolers were refitted.

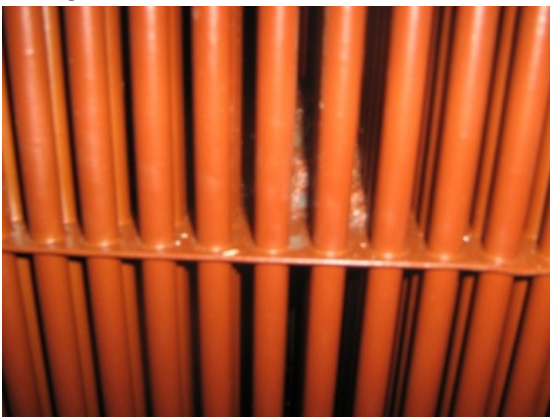
Box coolers after cleaning

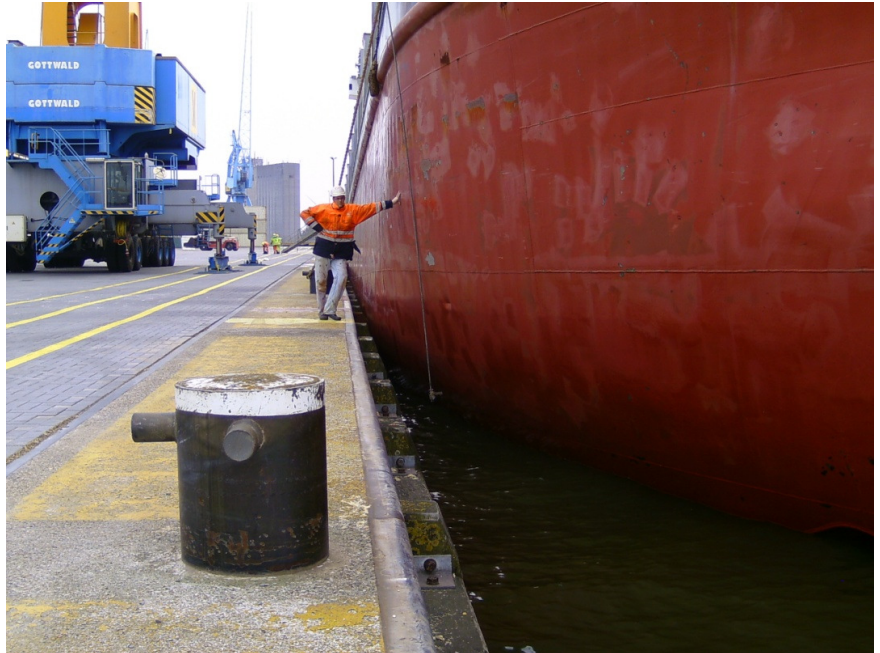
The above photograph was taken during trip 16 in the Terneuzen harbour. Draught: 1 metre

The USAF transmitters were only hung overboard when the vessel was not in motion. While underway, they were not in use, although they were activated when the vessel lay at anchor, provided currents were not too strong. Fouling is generally a problem in the northern Spanish harbours, the Mediterranean harbours, as well as in North Sea harbours.

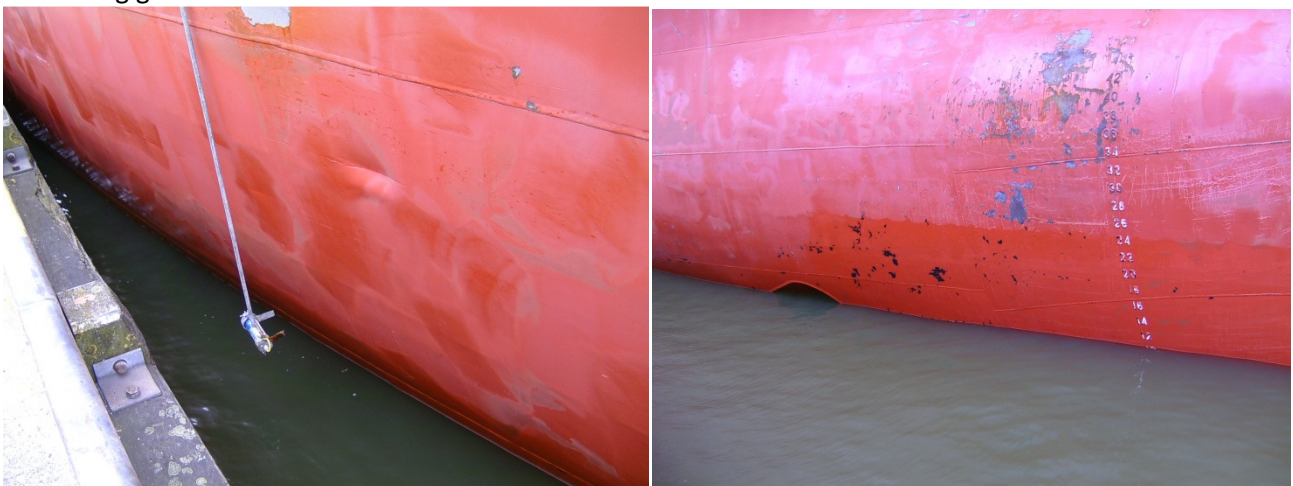
On these photographs, you'll see the hull around where the ultrasound head was placed. The paint is 9 months old and, within that period, the hull was not cleaned or touched up, but still looks new.

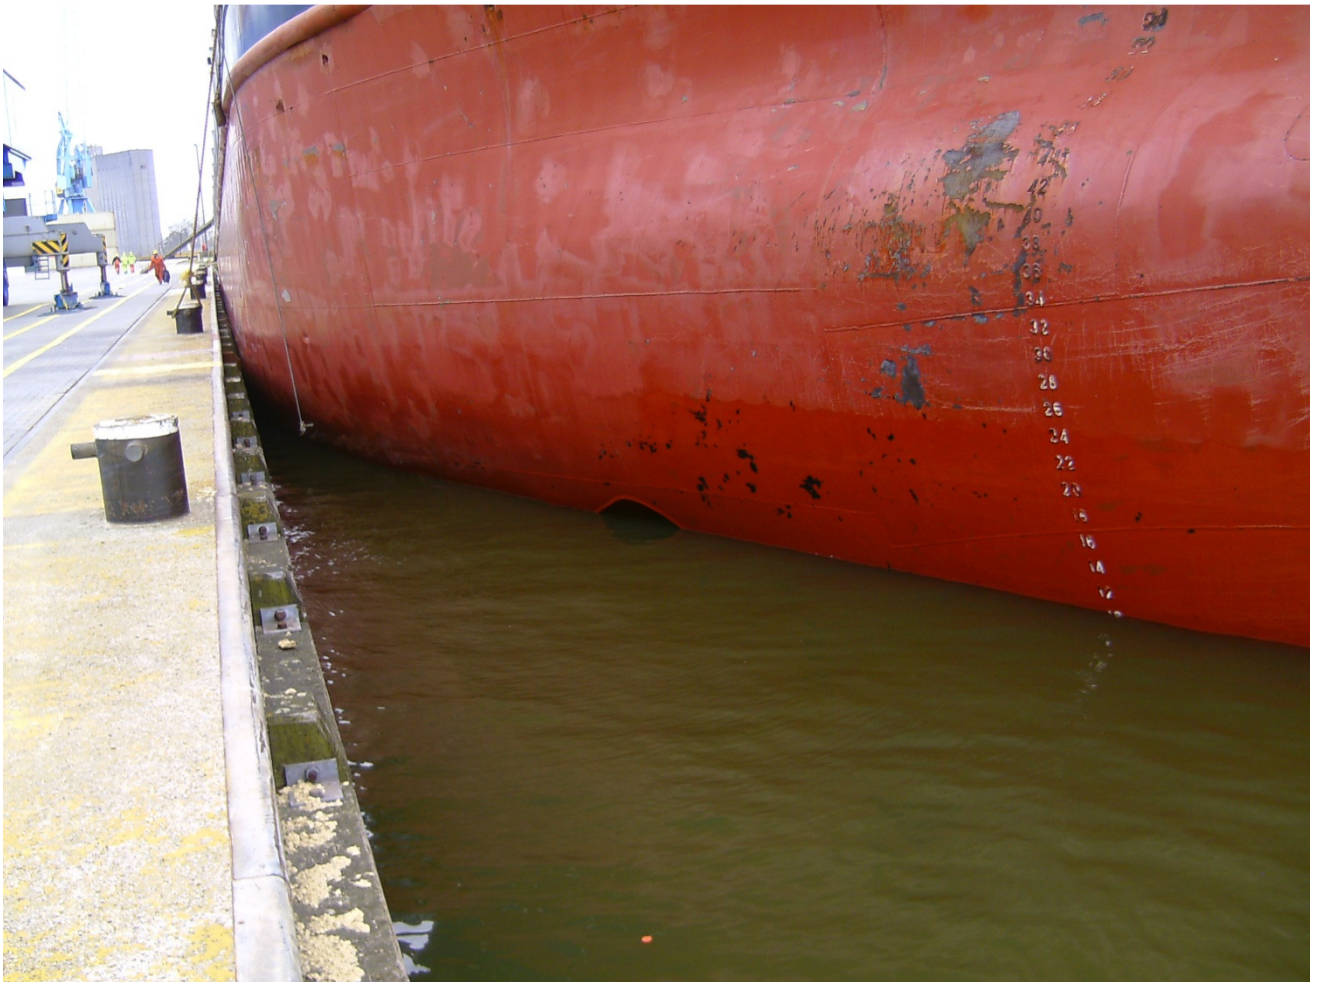
This photograph illustrates the entire bow of the vessel up to the ultrasound pod. This area has thus probably been indirectly – and not directly – affected by ultrasonic waves due to reflection off the quayside or mooring posts, and is completely free of fouling.

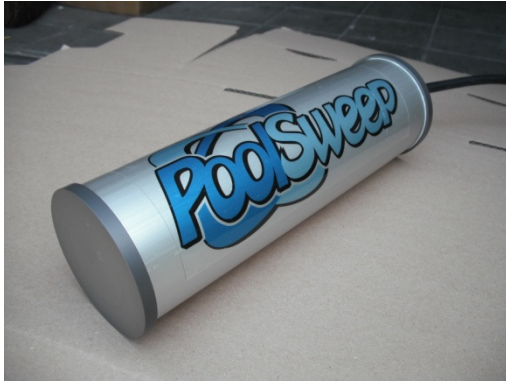
Ultrasound transmitter USAF®
